INDOOR AIR QUALITY ASSESSMENT

**Franklin Elementary School
2 Cypress Terrace
North Andover, Massachusetts**

Prepared by:
Massachusetts Department of Public Health
Bureau of Environmental Health Assessment
October 2002

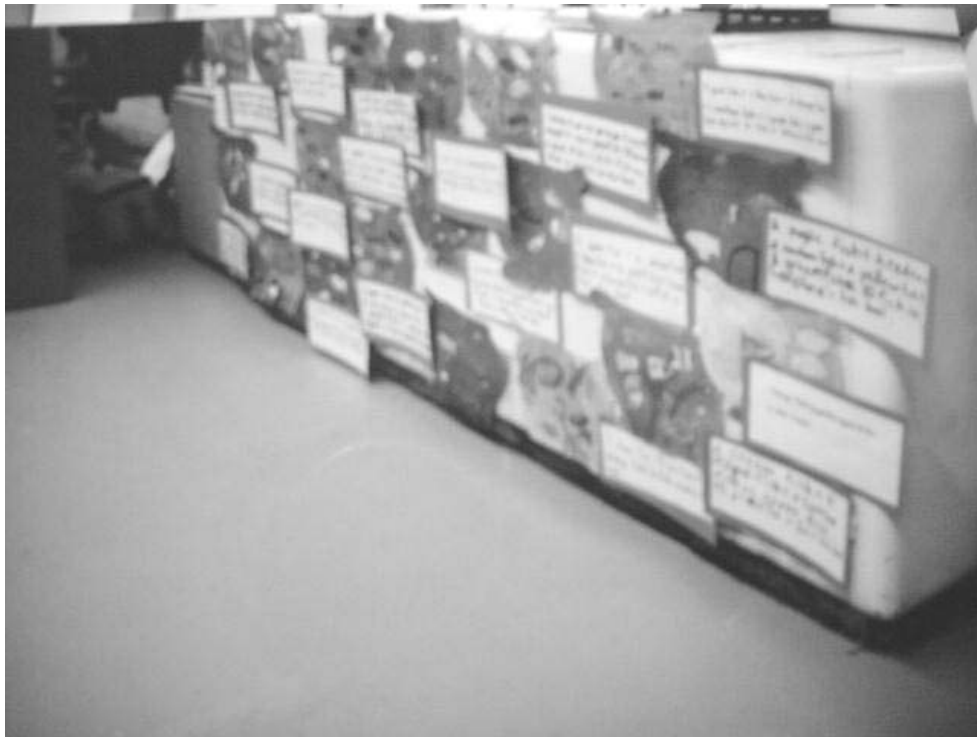
Picture 1

Univent Return Vent Obstructed by Items Taped to Front of Unit

- ventilation and air conditioning (HVAC) engineer concerning the calibration of univent fresh air control dampers school-wide.
3. Remove all blockages from univents and exhaust vents. Continue with plans to install egg crate-type ceiling tiles (as shown in Picture 4), where exhaust vents are obstructed.

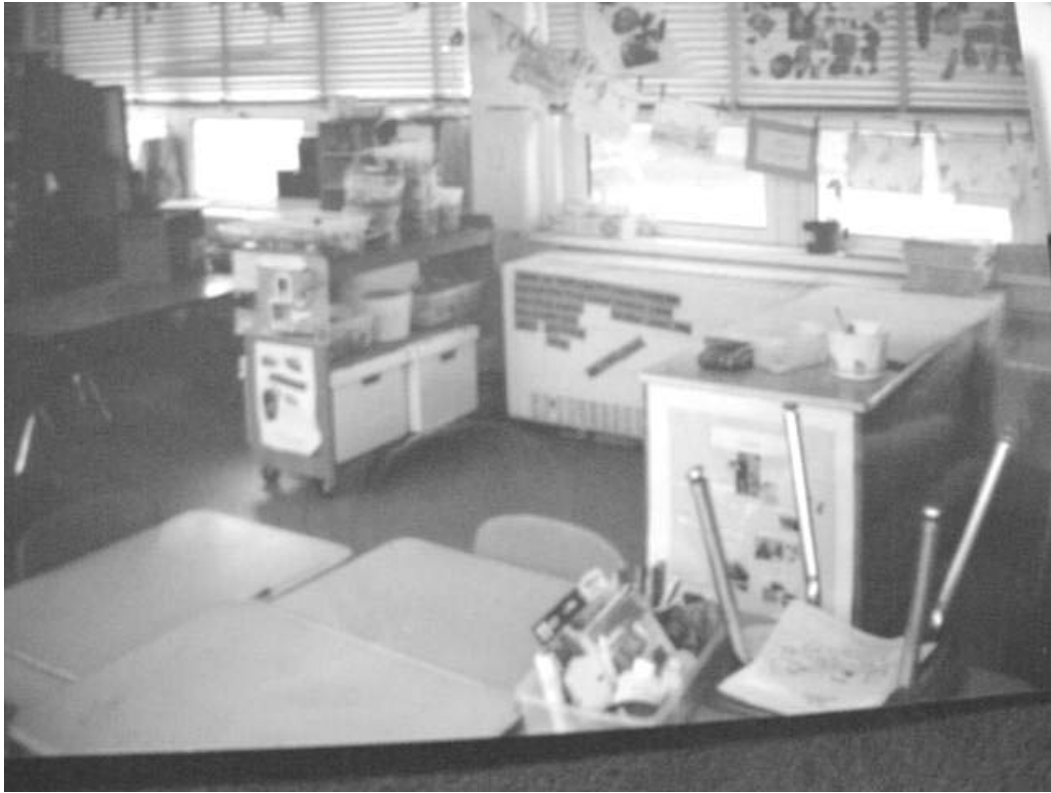
Picture 2

Bookcases and Carts Placed around Univent Obstructing Airflow

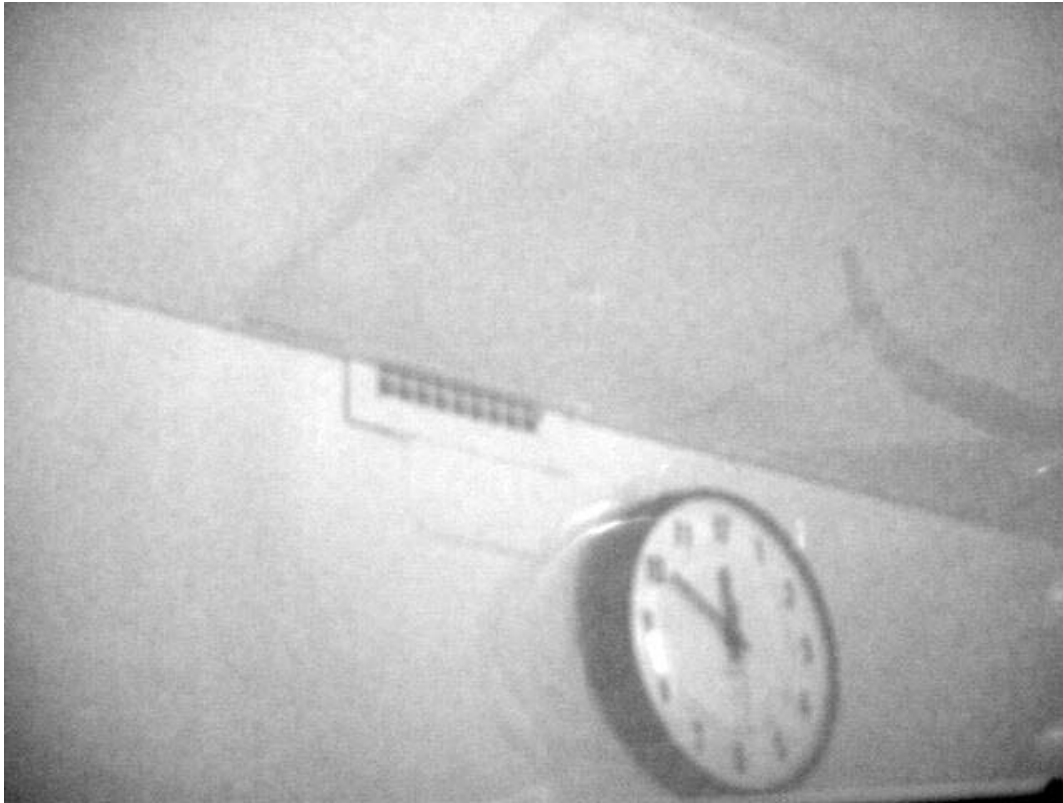
Picture 3

The mechanical exhaust ventilation system in classrooms in the 1958 wing consists of grated, wall-mounted exhaust vents. A number of exhaust vents were obstructed by tables, chairs, boxes and in some cases, ceiling tiles (see Picture 3). A dropped ceiling tile system was installed, which obstructed wall-mounted exhaust vents that are located near the ceilings. In a number of instances Mr. Mallioux has installed egg crate-type ceiling tiles, which allow airflow into the vent (see Picture 4). Exhaust ventilation in the 1968 wing is provided by unit exhaust ventilators (see Picture 5), many of which were off or drawing weakly. Without removal by the exhaust ventilation system, normally occurring environmental pollutants can build up and lead to indoor air complaints.

Wall-Mounted Exhaust Vent Obstructed by Dropped Ceiling Tile System

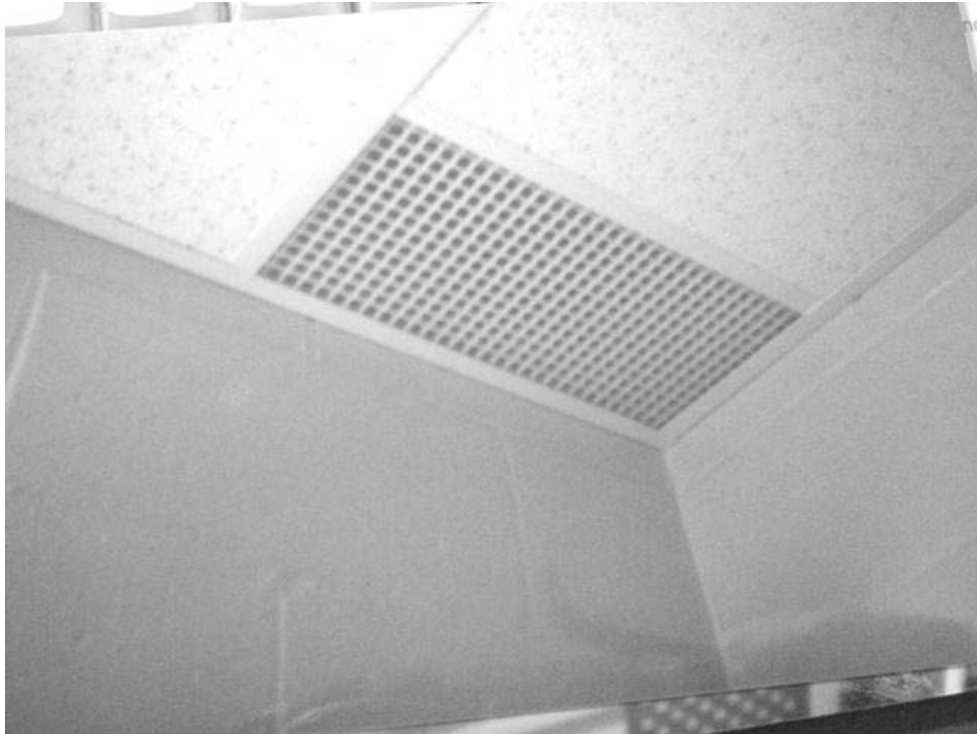
Picture 4

Egg Crate-Type Ceiling Tile

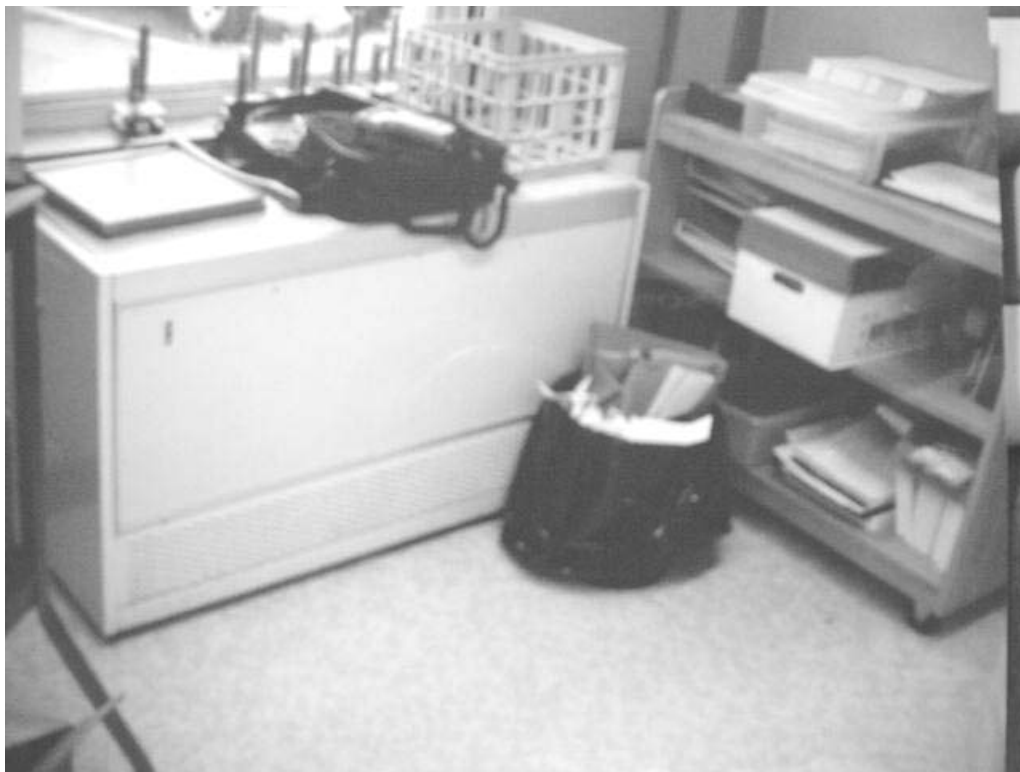
Picture 5

Unit Exhaust Ventilator

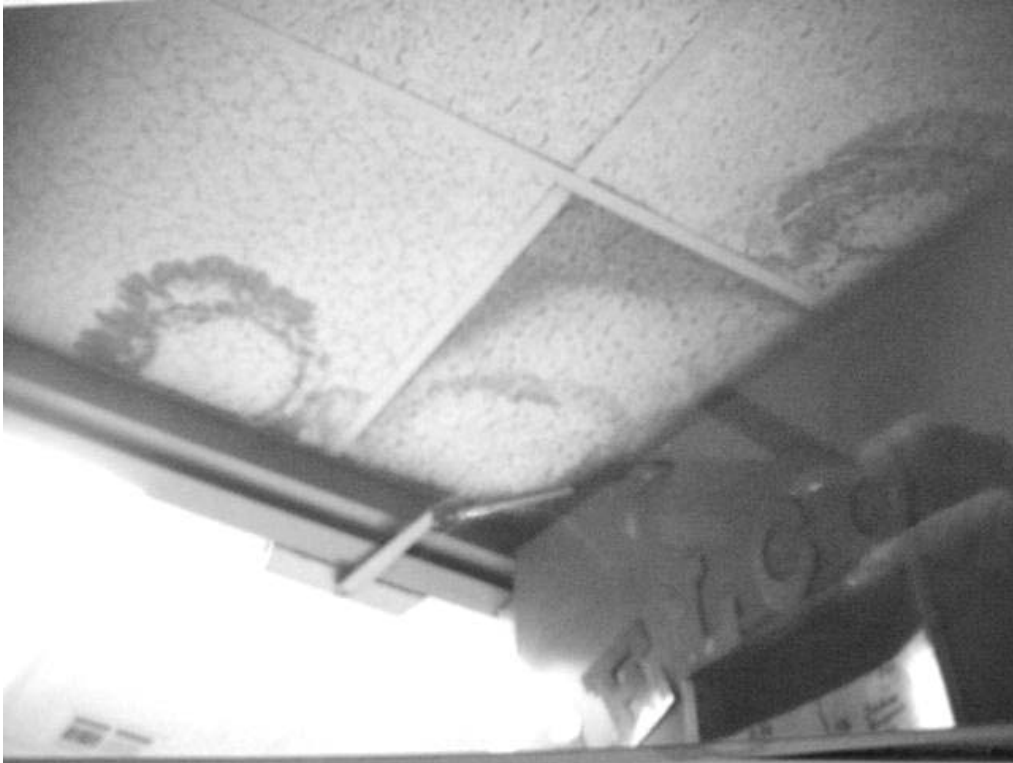
Picture 6

A few classrooms had water-damaged ceiling tiles which can indicate leaks from either the roof or plumbing system (see Picture 6). Water-damaged ceiling tiles can provide a source of mold and should be replaced after a water leak is discovered and repaired.

Water Damaged Ceiling Tiles

6. Replace any remaining water-stained ceiling tiles and building materials. Examine the area above and around these areas for mold growth. Disinfect areas of water leaks with an appropriate antimicrobial.

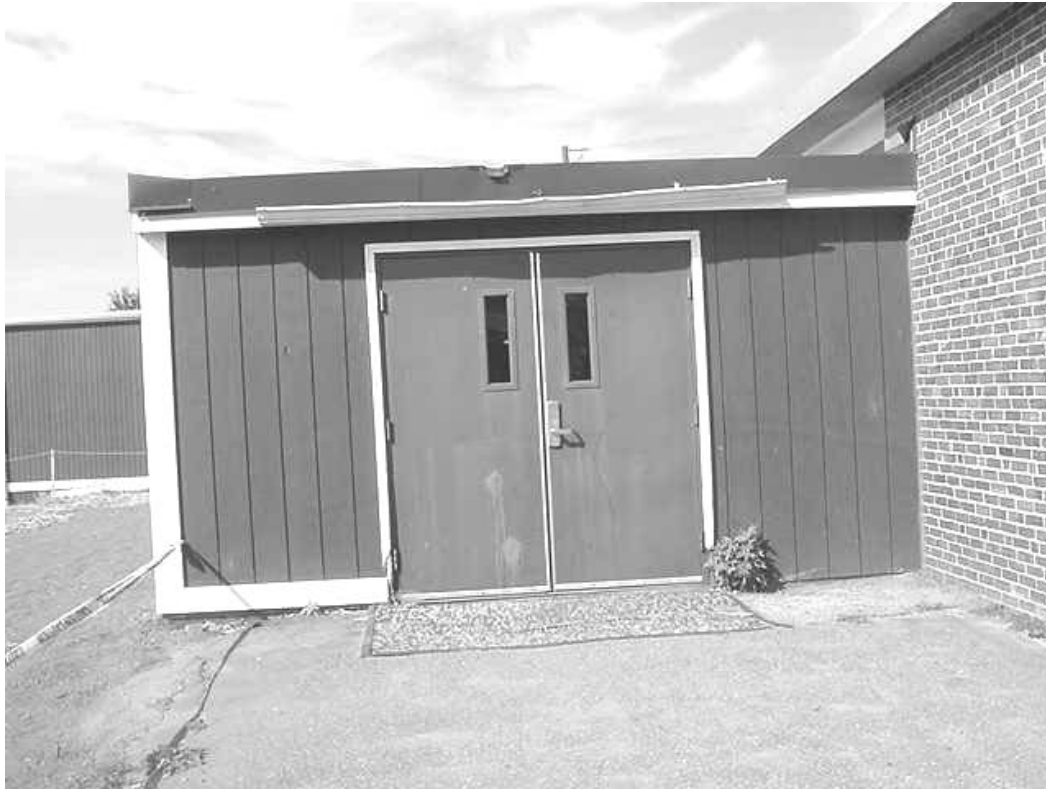
Picture 7

The exterior walls of the modular units appeared to be intact and drainage adequate. Two of the three modular classrooms are not equipped with a complete gutter/downspout system (see Pictures 7 & 8), which can allow rainwater to pool on the ground at the base of the building or against exterior walls. The freezing and thawing action of water during winter months can create cracks and fissures in the foundation. Over time, this process can undermine the integrity of the building envelope and provide a means of water entry into the building through capillary action through foundation concrete and masonry (Lstiburek & Brennan, 2001).

Modular Classroom Unit, Note Gutter Installed over Entrance Only

9. Consider installing complete gutters/downspout systems to modular classrooms to direct rainwater away from the building.
 10. Store cleaning products properly and out of reach of students.

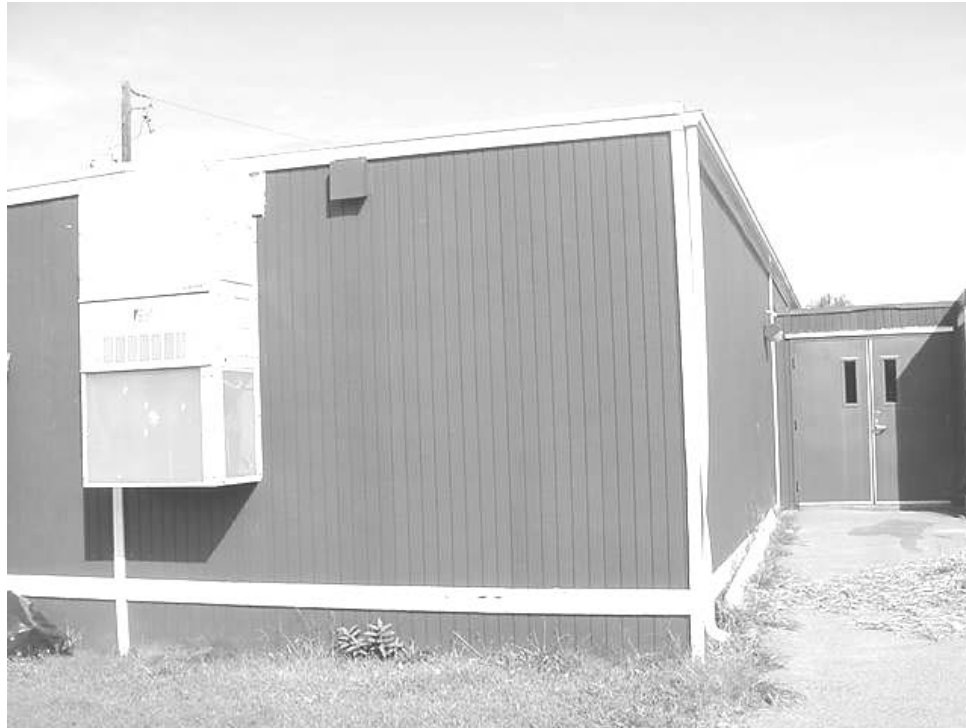
Picture 8

Modular Classroom, Note Lack of Gutter/Downspouts

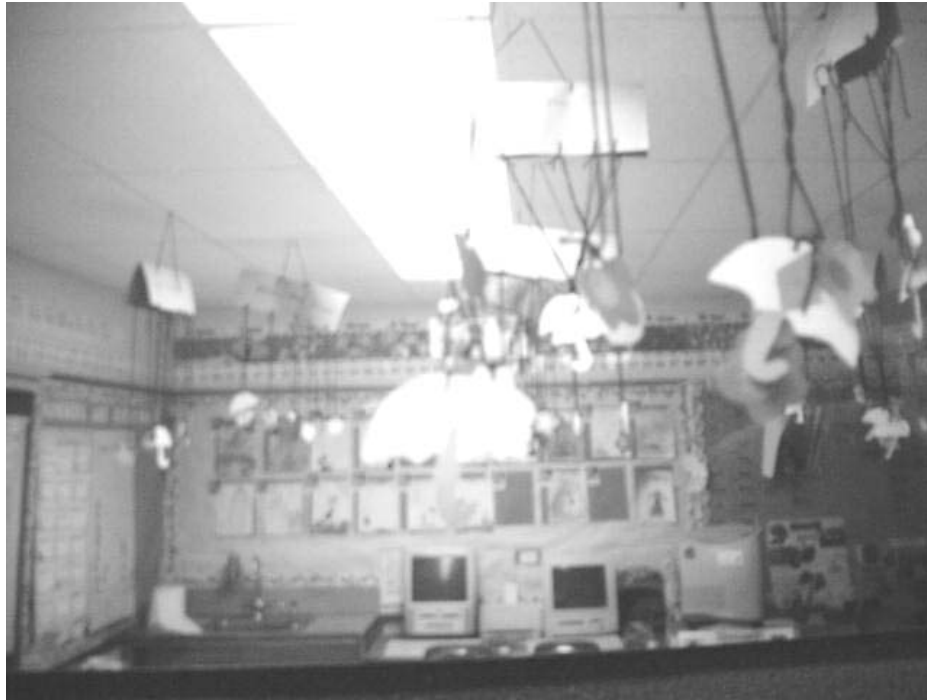
Picture 9

Items Hanging From Ceiling Tiles System in Classroom

11. Replace missing/damaged ceiling tiles. Refrain from hanging objects from ceiling tile system.
12. Clean chalkboards and trays regularly to avoid the build-up of excessive chalk dust.
13. Consider installing local exhaust ventilation in faculty workrooms to remove excess heat and odors from photocopier and lamination machine use.
14. Clean blades of portable fans and exhaust vents periodically of accumulated dust.
15. Relocate or consider reducing the amount of materials stored in classrooms to allow for more thorough cleaning. Clean items regularly with a wet cloth or sponge to prevent excessive dust build-up.
16. Discontinue the use of tennis balls on chairs to prevent latex dust generation.

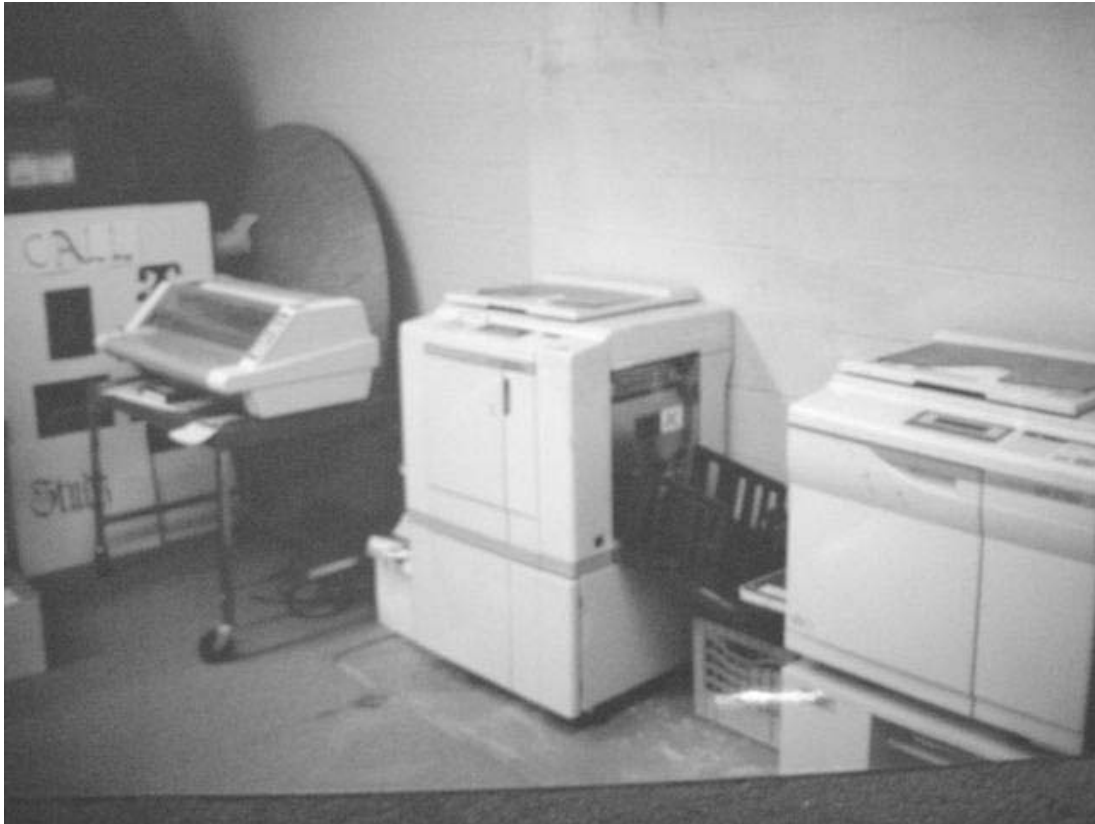
Picture 10

The book room contains a lamination machine and photocopiers (see Picture 10). No local exhaust ventilation was identified in this area. Lamination machines give off odors. VOCs and ozone can be produced by photocopiers, particularly if the equipment is older and in frequent use. Ozone is a respiratory irritant (Schmidt Etkin, D., 1992).

Lamination Machine and Photocopiers in Bookroom
